Technical Data Sheet #1

Resin bleed in treated pine decking

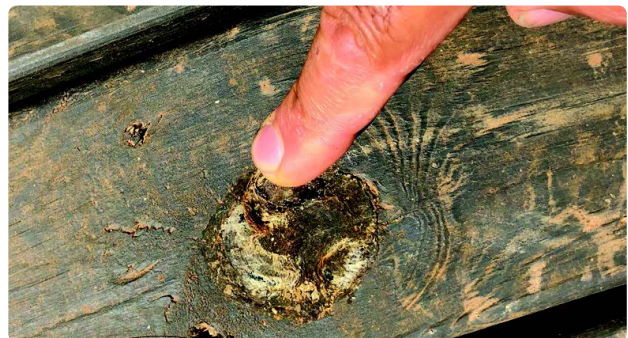
Resin can sometimes persist in wood even after a tree is sawn into timber products such as decking. When exposed to heat, resins can soften and mobilise, exuding from parts of the timber often around knots or other features of the natural timber structure: this is called "Resin Bleed".

In pine species, the resin often has a characteristic aroma, is typically sticky and can be clear or coloured. The areas of resin bleed are usually small and can affect finishes by bleeding under or through the finish. It is important to note that not all treated pine decking products will exhibit resin bleed and also that resin bleed does not affect the durability of the timber.

Pictured below: resin bleed around a knot.

As no two instances of resin bleed are exactly the same, the following recommendations are general in nature and may not prove effective in all cases. On delivery of your decking boards or after laying, you may notice resin bleed on small areas of the surface. The bleed should be scraped off and the area wiped with methylated spirits following manufacturers safety directions and then left for a week or more if possible to see if any further bleeding occurs. If bleeding has ceased, boards may now be finished with your preferred coating* following the manufacturer's directions.

It is highly recommended that a light-coloured finishing system is used as this will help to minimise heat gain in the timber which will discourage further resin bleed** and will have the added benefit of being cooler underfoot.

If resin bleed occurs after application of the finishing system, the local area can be scraped and cleaned and the finishing system re-applied in the area.
